## **1.0 Decay mechanisms associated with natural sedimentary stones and masonry substrates**

### **□ Problems associated with O.P.C and its deteriorological effect upon porous substrates**

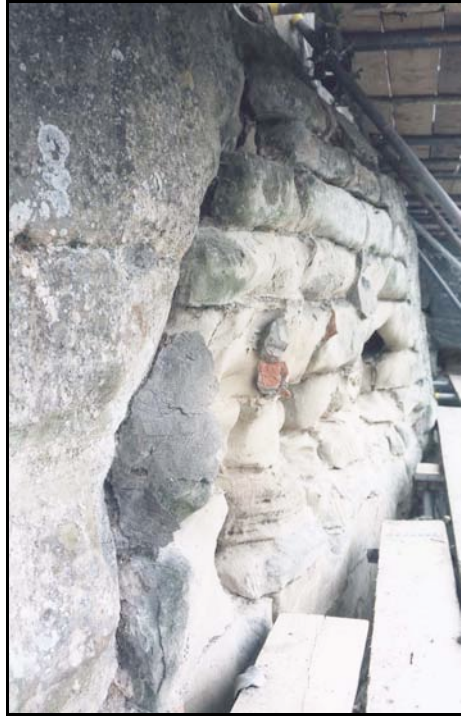
**Plate x: Warwick castle stone erosion**

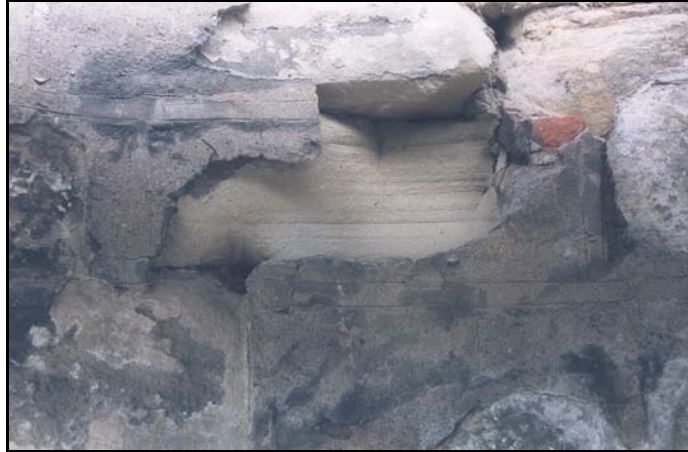
**Plate x: erosion of sedimentary stone at Warwick Castle**
